# A Practical Solution

*3CR12 helps solve corrosion problems in quarries, Phil Shirley reports*

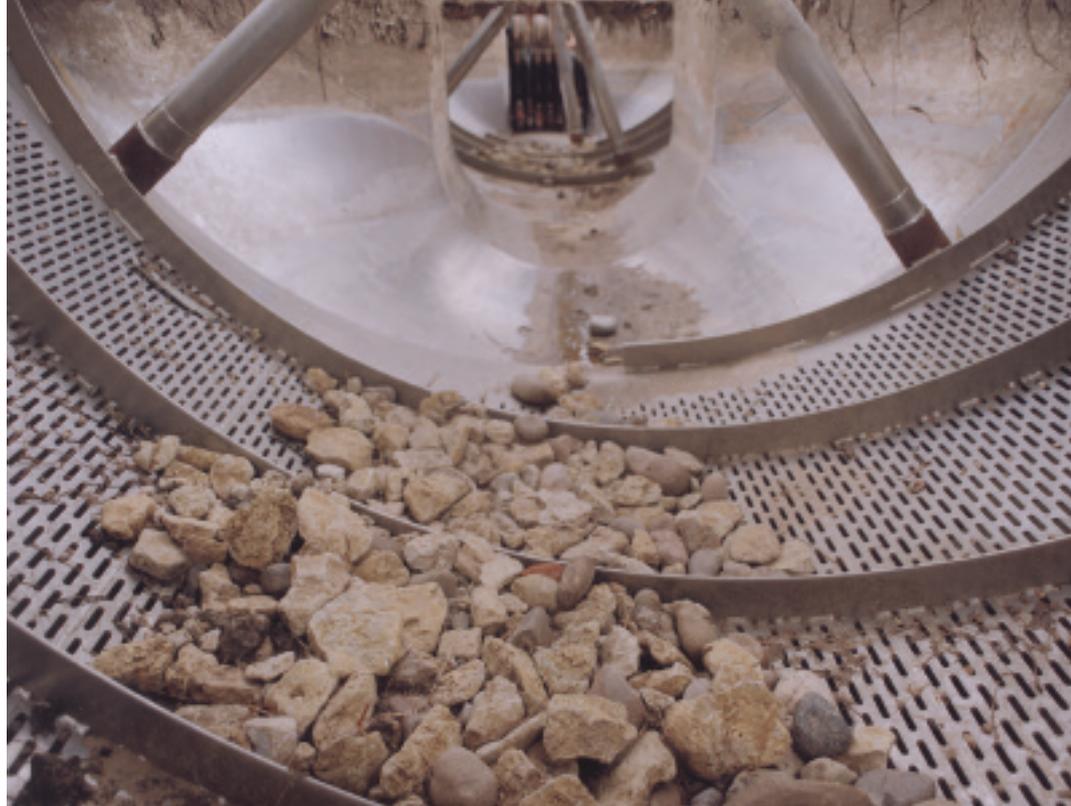
*A rotary screen constructed from 3CR12 stainless steel*

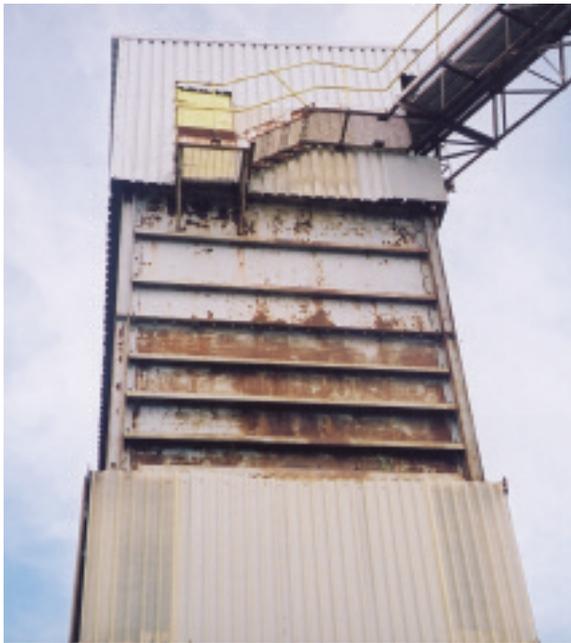
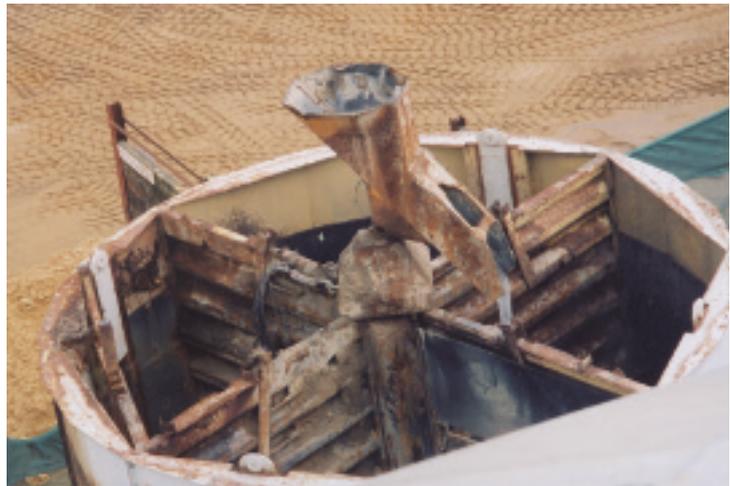
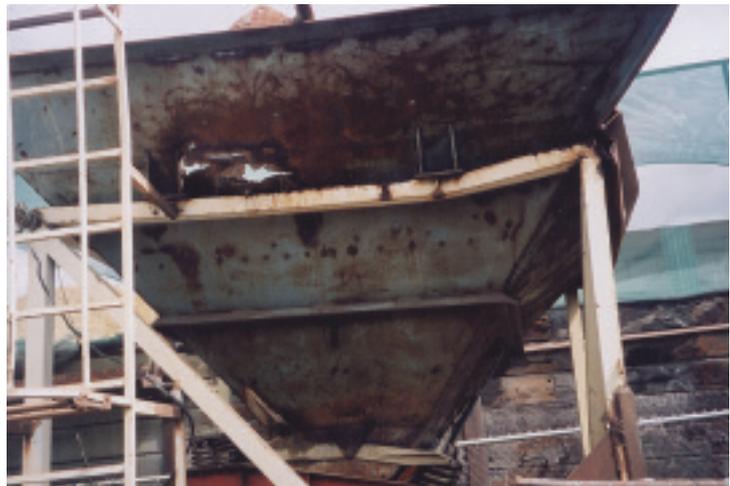
Examples of corroded mild steel — a silo building (above), a mixer (top right), and a hopper (right)

Historically it has been shown that mild steel corrosion will continue once a surface oxide has formed, due to the porous nature of the corrosion product. If this product is undisturbed the rate of corrosion will reduce, but if mechanical action removes the corrosion product periodically the rate of attack will remain significantly high. ►

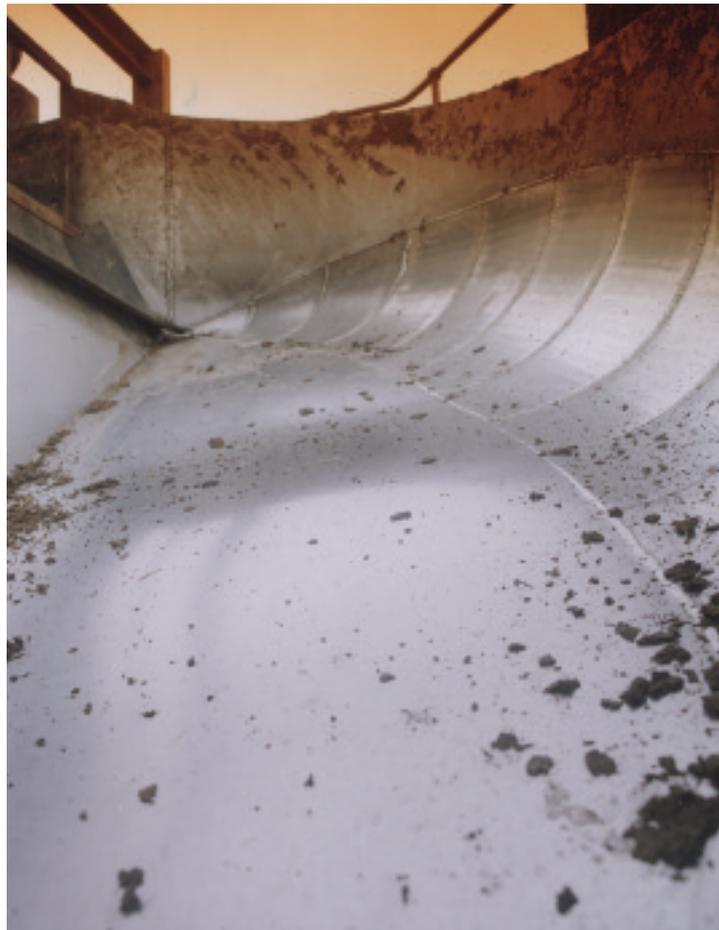
*This eight-year-old chute constructed from 3CR12 is still as good as new*
