Certified Second Life

Finning engineers rebuild Cat 775B dumptruck for Hanson Aggregates' Whatley Quarry, giving the vehicle a completely new lease of life

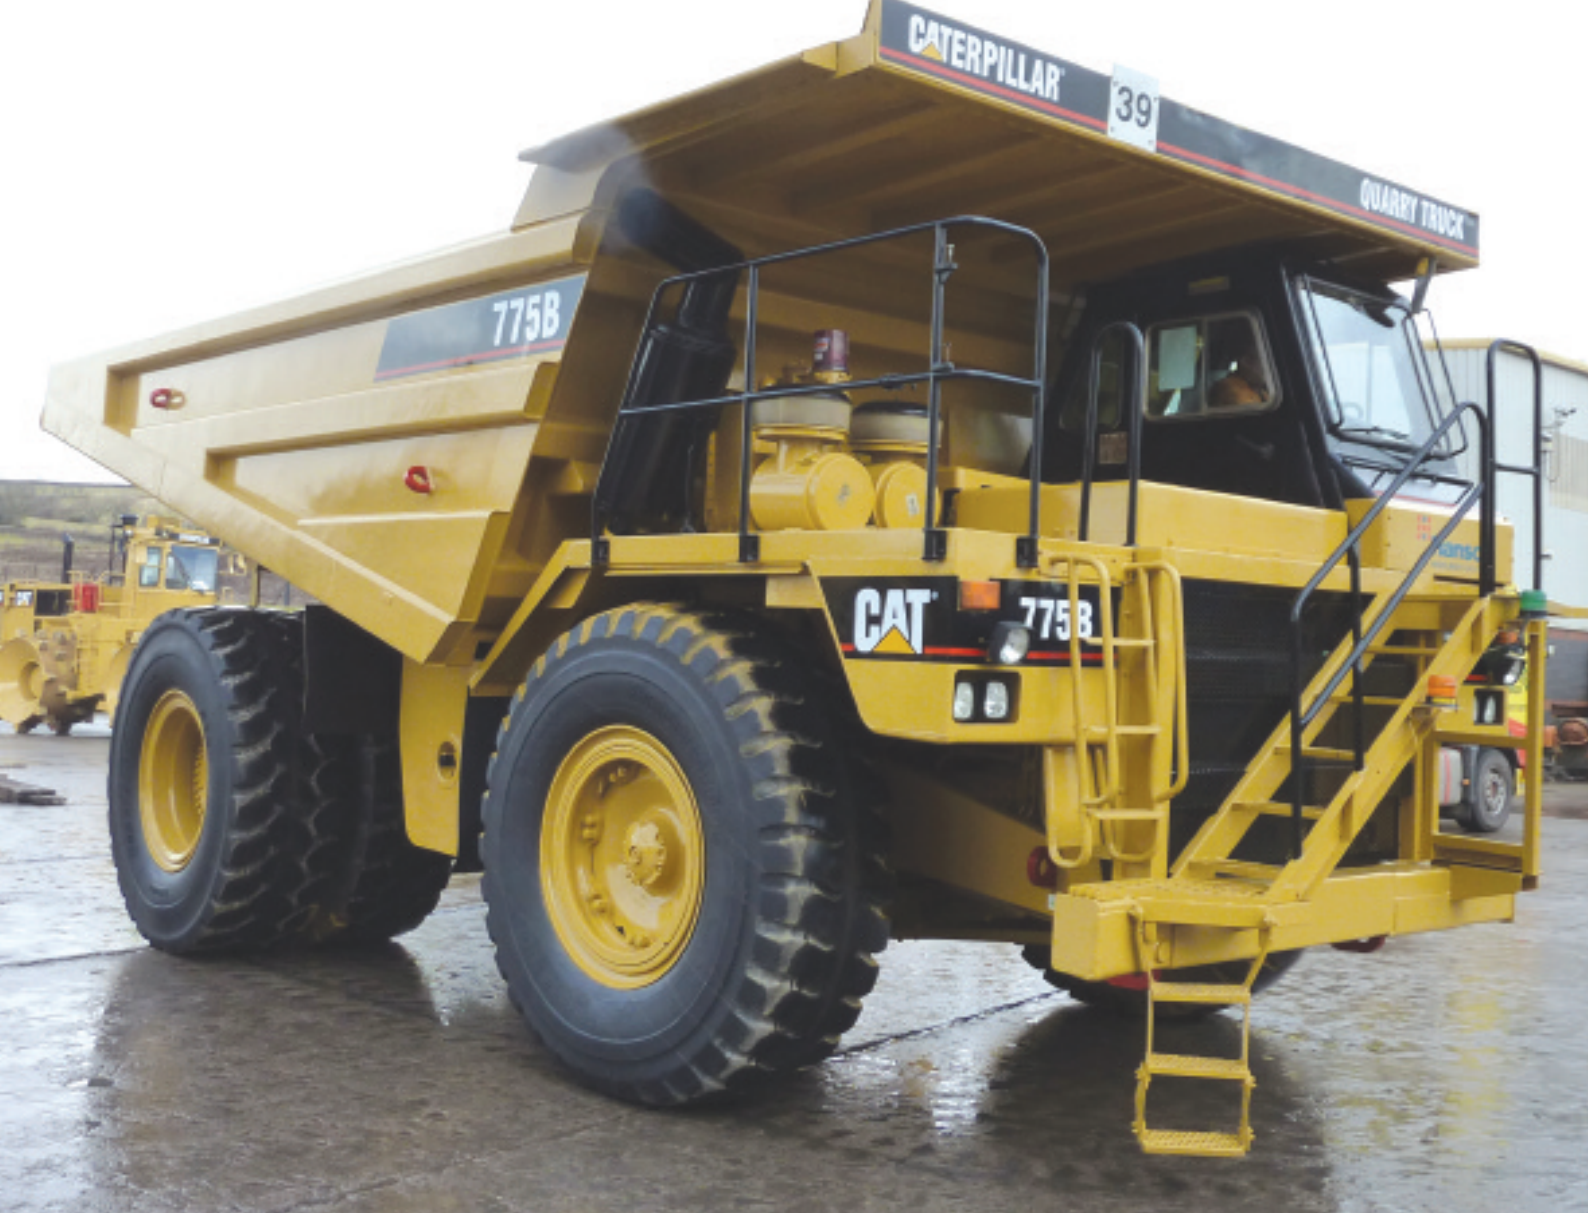
Hanson's newly rebuilt Cat 775B dumptruck

Once the decision had been made to rebuild the Cat 775B, it was transported to Finning's rebuild centre in Llantrisant, where it was thoroughly washed and inspected before work began. The unit was then stripped down; the skip was removed along with the radiator, engine, torque converter, differential and bevel gear, final drive and brakes, rear axle, hydraulic cylinders and pumps. 'Throughout this ►

Some 3,500 components later the Cat 775B moved into the final stages of its rebuild, when it was re-sprayed and had new livery applied. In just eight weeks Finning engineers gave the dumptruck 'Lastability', injecting a second life into the vehicle. 'Although we have done other rebuilds for Hanson, this is the first certified rebuild we have done for them, and it has been
